**ARCH SABER PRIMARY CLEANERS
REMOVE CARRYBACK AT THE HEAD
PULLEY AND ALLOW THE
MATERIAL TO FALL INTO THE BULK FLOW**

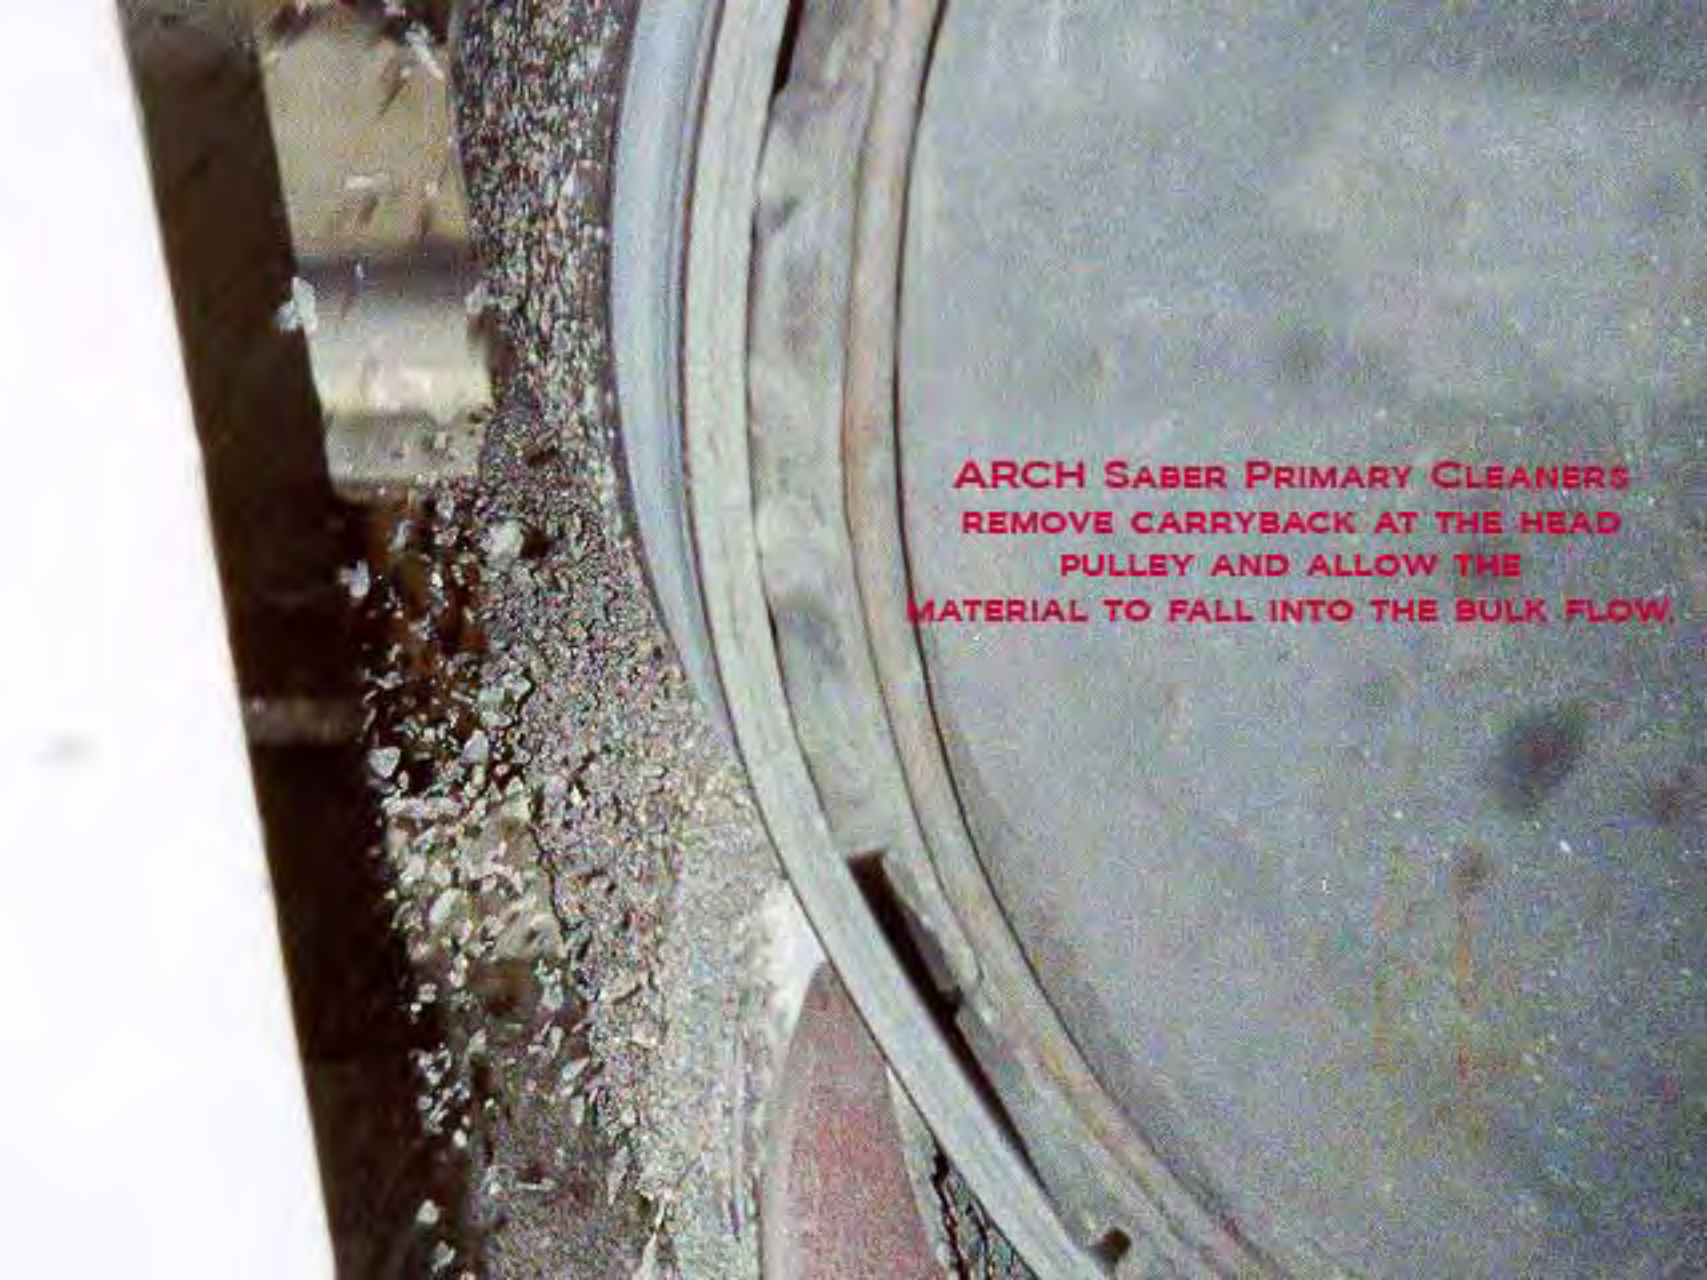
A close-up photograph of a conveyor belt pulley system. The pulley is covered in a grey, textured rubber lagging. A metal scraper blade is positioned to clean the lagging. To the left of the pulley, a metal structure is visible, and a stream of dark, granular material is falling from it. The text is overlaid in red on the right side of the image.

**ARCH SABER PRIMARY CLEANERS
REMOVE CARRYBACK AT THE HEAD
PULLEY AND ALLOW THE
MATERIAL TO FALL INTO THE BULK FLOW**

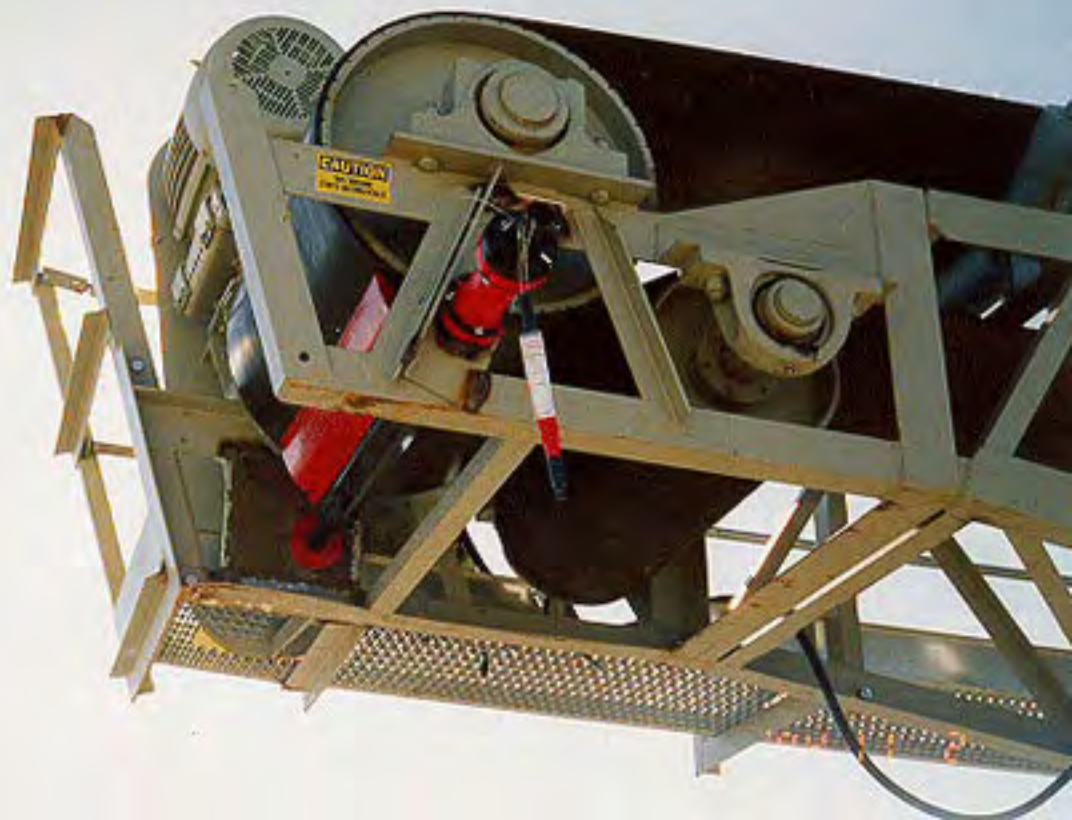
**Mechanical splices pass with
ease.**

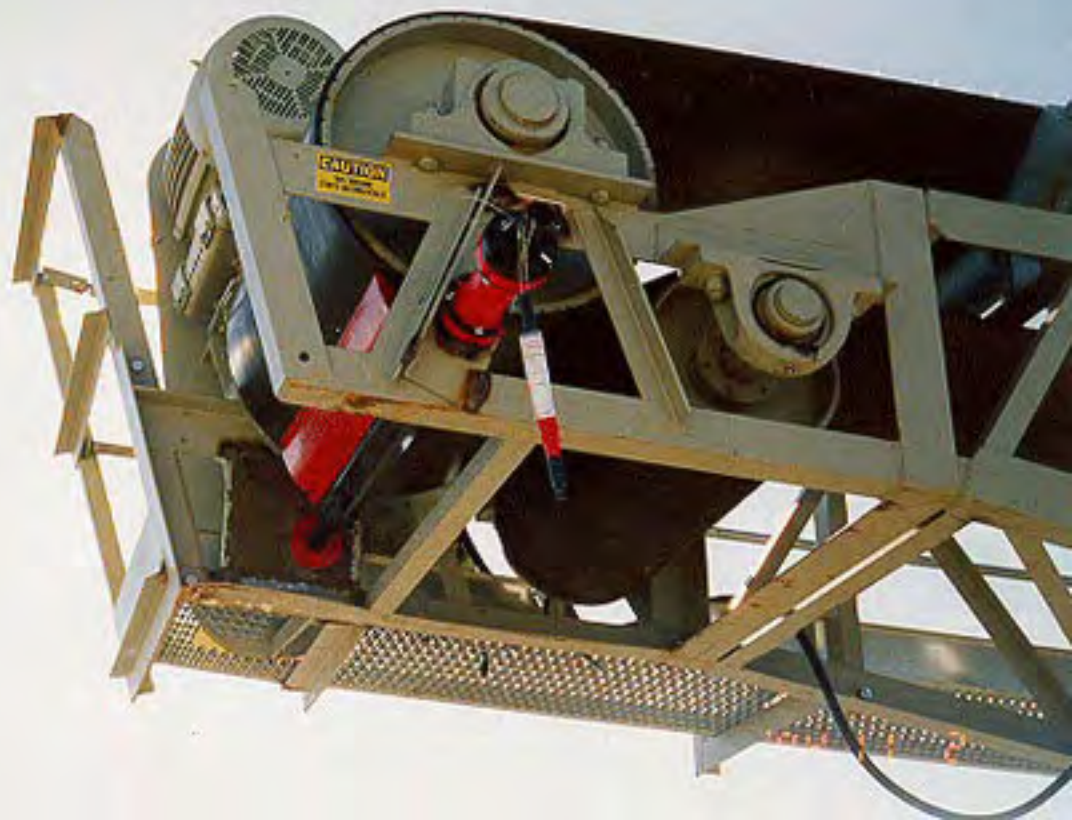
**Mechanical splices pass with
ease.**
